# Understanding **MP6500** Current Control

## Application Note

*Prepared by Pete Millett*

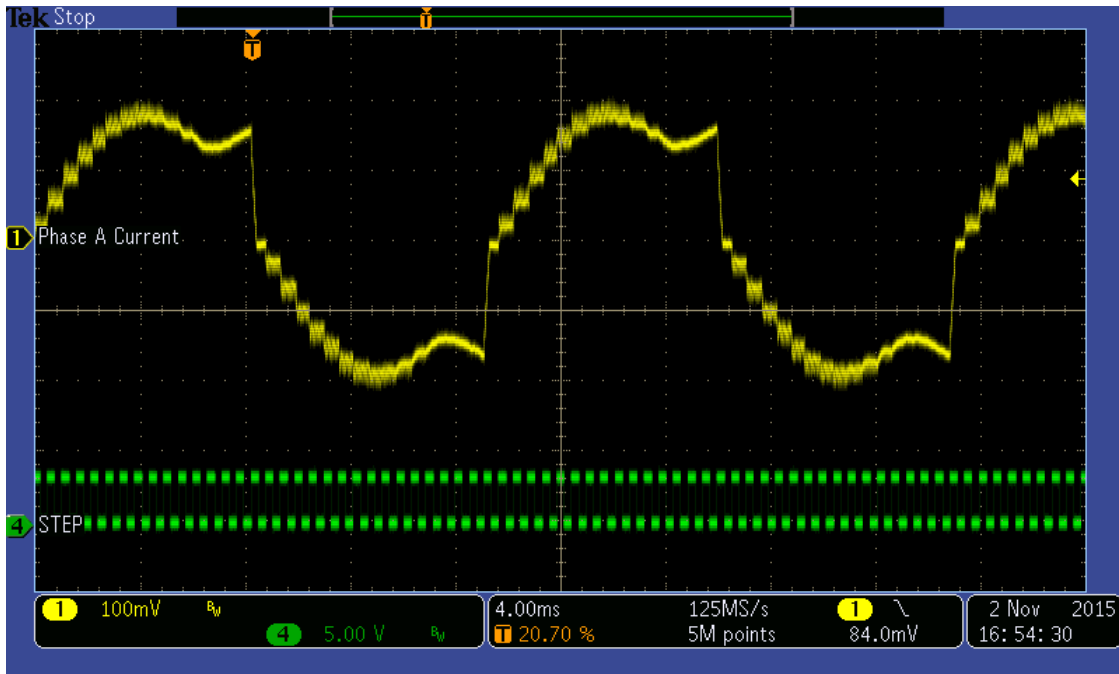
To prevent falsely sensing the current spike that occurs at the beginning of a PWM cycle due to the winding capacitance, there is always a short blanking period during which the current level is ignored. The fact that the winding is always driven during this blanking time can cause the current to actually *increase uncontrollably*. This results in severe current waveform distortions and poor motion quality (see Figure 3).

**Figure 3: Current Distortion in Slow Decay Mode**

After the peak of the sine wave, the current starts toward zero at first and then increases until the H-bridge is tri-stated during the zero-current segment.

As we saw in Figure 3 above, at very high step rates, normal current control techniques can fail to keep the winding current in control. As the motor turns faster and faster, the back EMF makes it more difficult to increase the current, and there is less time available in which to decrease the current. At some point, this results in the inability of the motor to generate torque, resulting in a stall.
